Geomorphic Assessment using the Watershed Assessment of River Stability and Sediment Supply (WARSSS)

**Macatawa Watershed
Ottawa and Allegan Counties, Michigan**

Prepared for:
Macatawa Area Coordinating Council
Holland, Michigan

**April 27, 2011
Project No. G100240**

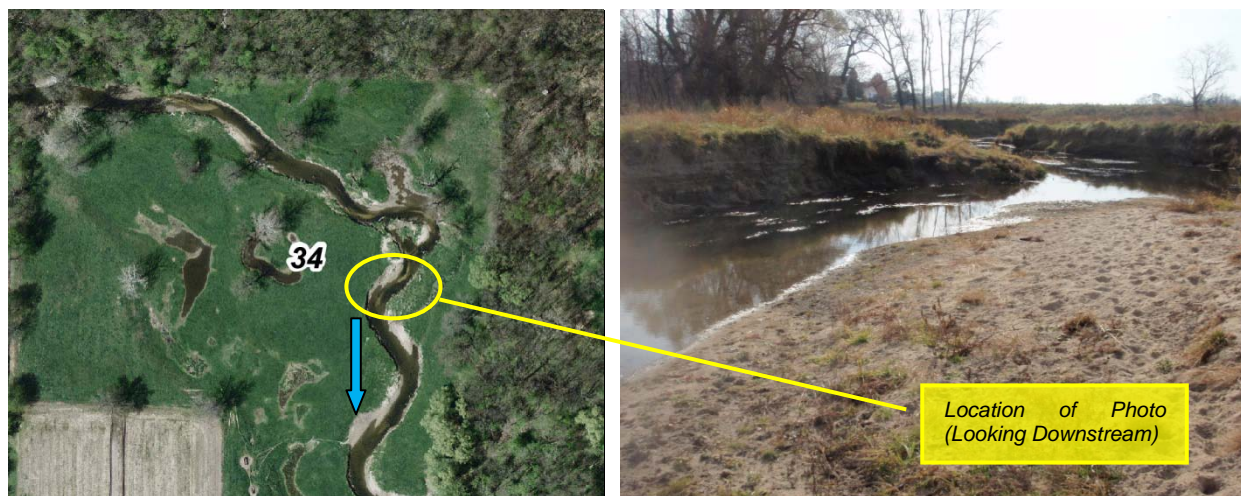
High quality, leaf-off aerial imagery was provided by Ottawa County. These photographs were valuable in identifying potential areas of instability including channel bank erosion, sediment deposition (point bars and mid-channel bars), and log jams. Below is an example of how aerial imagery was used to identify areas of instability. The photographs are taken along the main-stem of the Noordeloos Creek in Section 14 (Subwatershed 34) of Holland Township between Chester Drive and Meadow Drive.

Aerial Photograph of Noordeloos Creek (Left) compared to Photograph of Site from Field Inspection (Right)

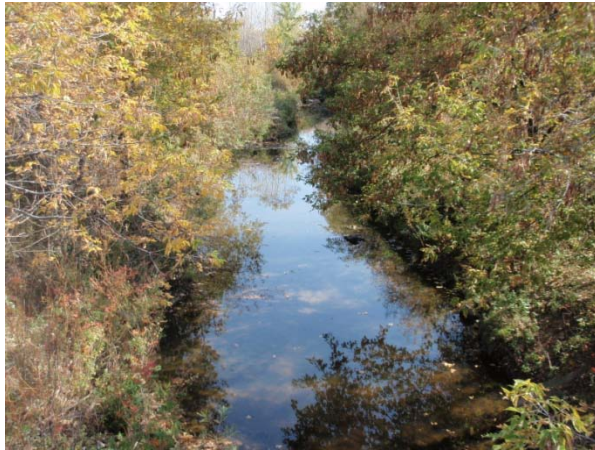
N. Branch of Macatawa Upstream of Lincoln Avenue

The upper (southern) portion of the North Branch subbasin consists of fairly linear, dredged trapezoidal drains through agricultural lands. While the dredged channels are generally deeper than a natural stream, the banks are quite stable due to the dense vegetative covering and fairly cohesive underlying soils. As indicated by the MACC study, the BEHI scores are generally low and contribute very little in terms of sediment loading. The exception appears to be the Kuipers Drain in Section 24 of Laketown Township, Allegan County, which is severely incised and actively eroding (in terms of both the channel bottom and banks) as documented in a recent study by FTC&H conducted on behalf of the Allegan County Drain Commissioner. Preliminary estimates indicate that the Kuipers Drain has some of the highest in-stream erosion rates in the watershed and is generating as much as 500 tons of sediment annually from streambank and streambed erosion.

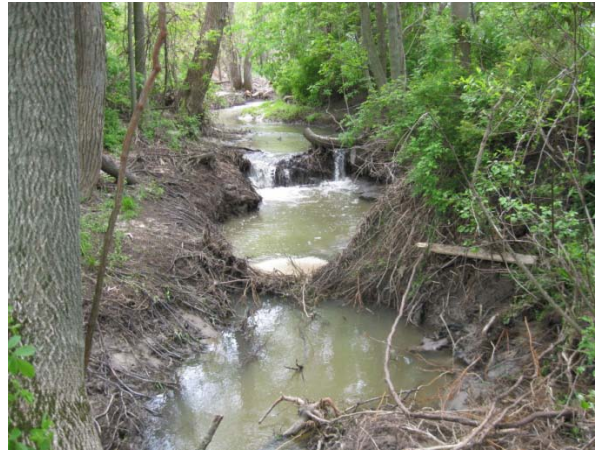
Headcut along Kuipers Drain

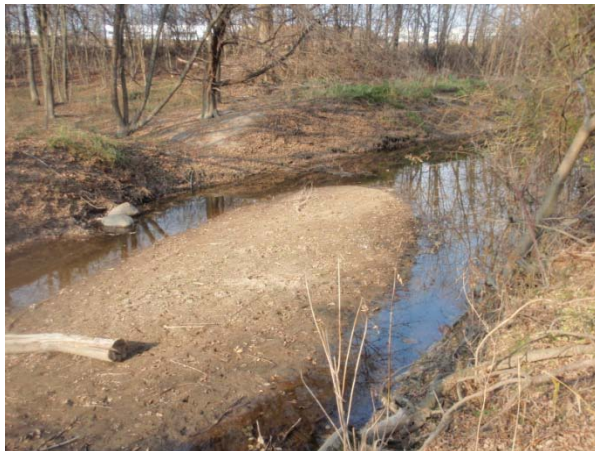
The degree of channel instability increases in the downstream receiving streams, especially along the North Branch of the Macatawa River itself. Erosion along meander bends and valley walls, channel degradation, tributary head-cuts, log jams, and mid-channel bars are common along the North Branch of the Macatawa River, especially downstream of the M-40 corridor, which has undergone extensive industrial and commercial development over the past few decades.

Mid-Channel Bar downstream of M-40

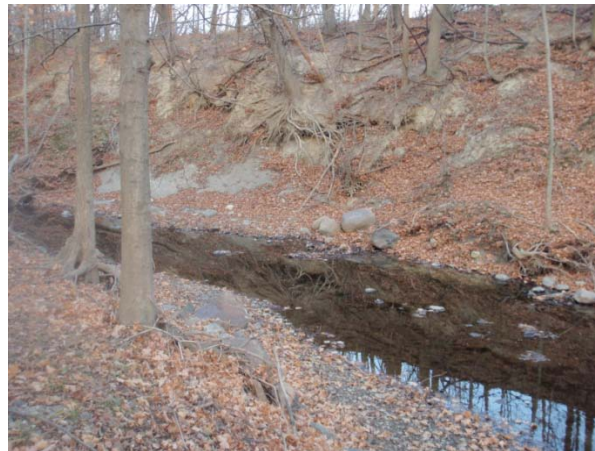
Erosion along Valley Wall downstream of 147th Street

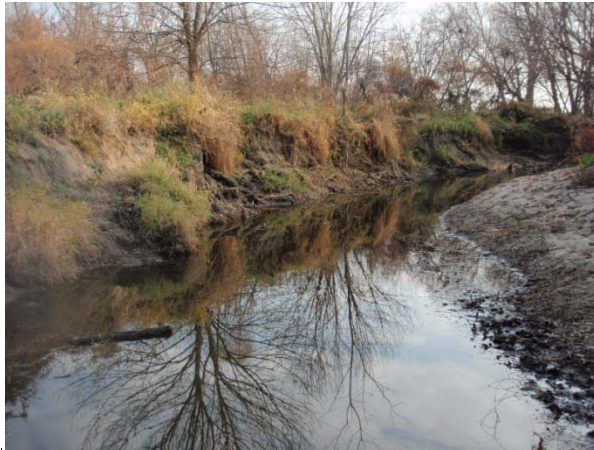
The severity of bank erosion and channel instability is most severe between M-40 and 32nd Street (Ottogan Road) as shown in Figure 6. The majority of the North Branch of the Macatawa River is deeply incised along this stretch, resulting in higher flows and associated shear stresses being confined to the channel. Low bank heights of 5 to 7 feet are common in areas where the mean bankfull depth should be approximately 2.5 feet. The related Bank-Height ratios (lowest bank height to maximum bankfull depth) are greater than 1.5, indicative of a stream that is lowering its local base level (degrading) and capable of contributing a disproportionate amount of sediment from stream bank (and bed) erosion.

Incised Channel downstream of M-40

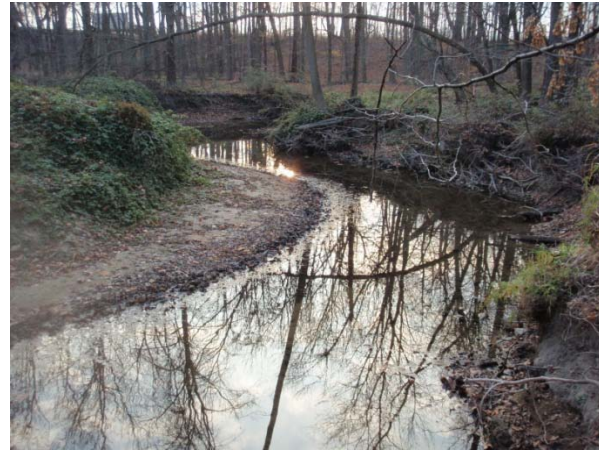
Incised Channel upstream of 32nd Street

The most severe erosion in terms of degree and extent (sediment loading) along the North Branch of the Macatawa River is between M-40 and 32nd Street (Ottogan Road). Over 86% of the channel along this stretch is experiencing some level of bank erosion. On average, this reach is contributing an estimated 0.6 cubic feet per linear foot or 385 tons of sediment annually from in-stream erosion. Overall, the North Branch sub-basin is estimated to contribute approximately 1,235 tons of sediment annually from bank erosion, the second highest of all eight major subbasins. A detailed breakdown of pollutant loading by stream reach is shown below in Table 5. Pollutant loading calculations are provided in Appendix 5.

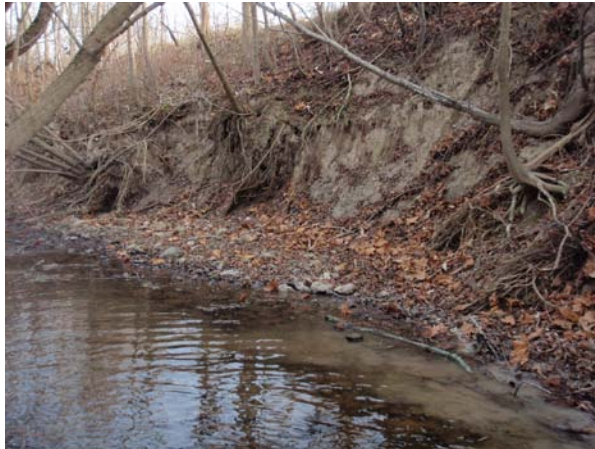
although some of the tributaries were determined to be fairly stable based on the windshield survey. Erosion at the toe of banks and along meander bends and valley walls was common. Signs of channel degradation, including increased channel incision and tributary head-cuts, were noted. Extensive log jams causing localized scour and erosion were also prevalent.

Erosion of Valley Wall between 146th & 46th Streets

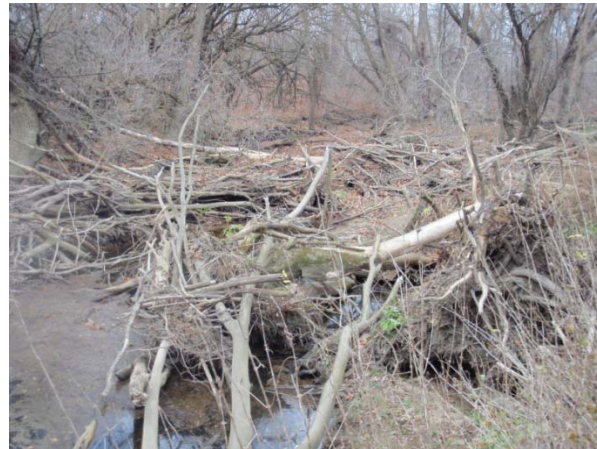
Log Jam downstream of 46th Street

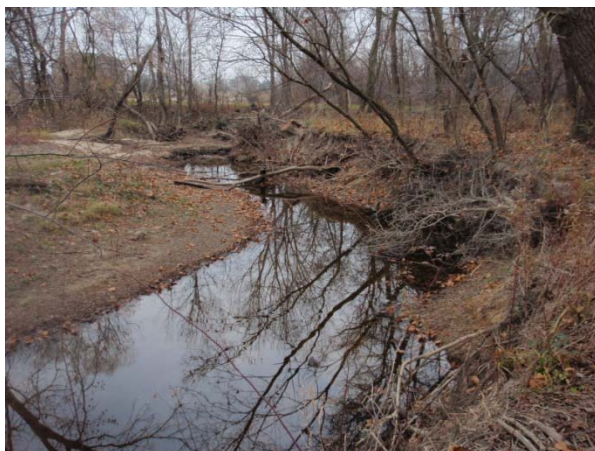
The most severe erosion along the South Branch of the Macatawa River is downstream of 46th Street. On average, this reach is contributing an estimated 0.8 cubic feet per linear foot or 620 tons of sediment annually from in-stream erosion. Nearly the entire stretch is deeply incised with low bank heights between 5 and 7 feet in areas where the bankfull mean depth should be less than 3 feet. The related Bank-Height ratios (lowest bank height to maximum bankfull depth) are greater than 1.5, indicative of a stream that is lowering its local base level (degrading) and capable of contributing a disproportionate amount of sediment from stream bank (and bed) erosion.

Incised Channel between 46th St. and Ottogan St.

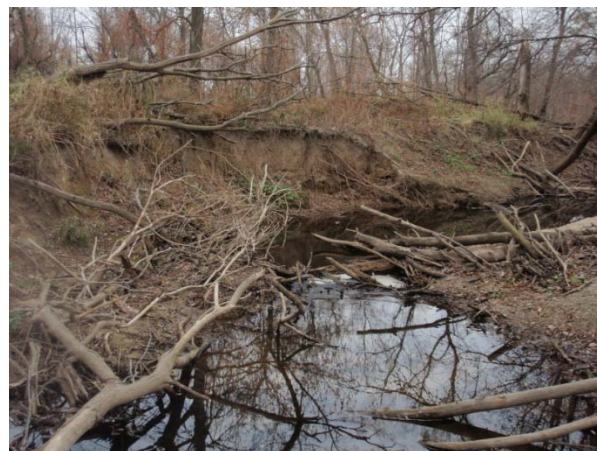
Incised Channel near Black River

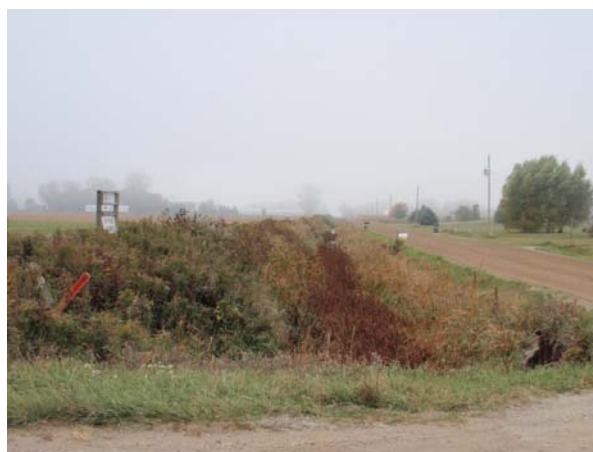
Tributary at 96th Street and Van Buren Street

In general, the dredged open channel drains through agricultural lands in the upper part (north and east) of the Noordeelos Creek subbasin tend to be fairly stable. This is most likely due to the lower channel gradients (and associated shear stresses), more cohesive soils, and well-vegetated banks.

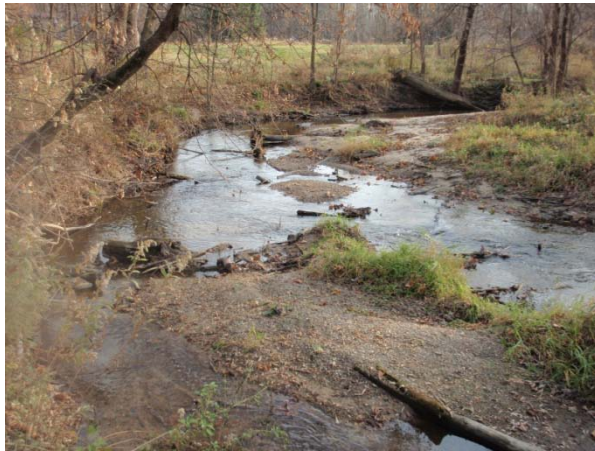
While the altered (dredged) agricultural drains may be fairly stable, the receiving natural channels show classic signs of instability from altered hydrology (both agricultural and urban development/channelization). Erosion along meander bends and valley walls, channel degradation, tributary head-cuts, fallen trees and log jams, mid channel bars, transverse riffles, and meander bends (pools) with steep

Mid-Channel Bar downstream of I-196 BL

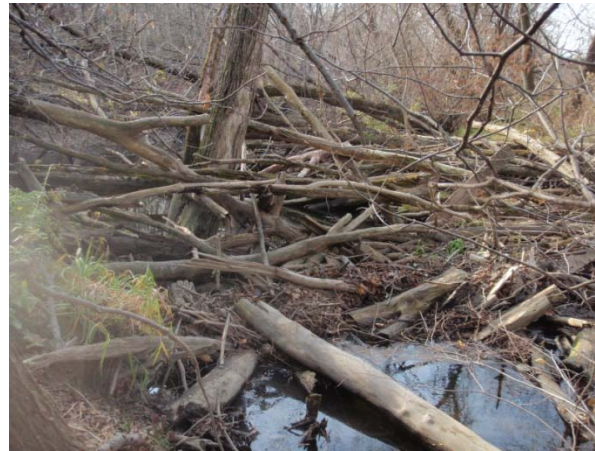
Severe Log Jam downstream of Riley Street

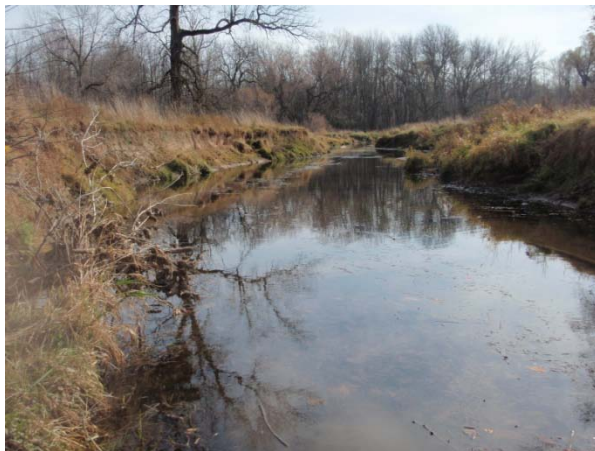
Incised Channel downstream of Riley Street

Not surprisingly, the most severe erosion in terms of degree and extent (sediment loading) is along Noordeloos Creek, downstream of Riley Street. On average, this reach is contributing an estimated 0.6 cubic feet per linear foot or 660 tons of sediment annually from in-stream erosion. Overall, the Noordeloos Creek subbasin is estimated to contribute approximately 951 tons of sediment annually from bank

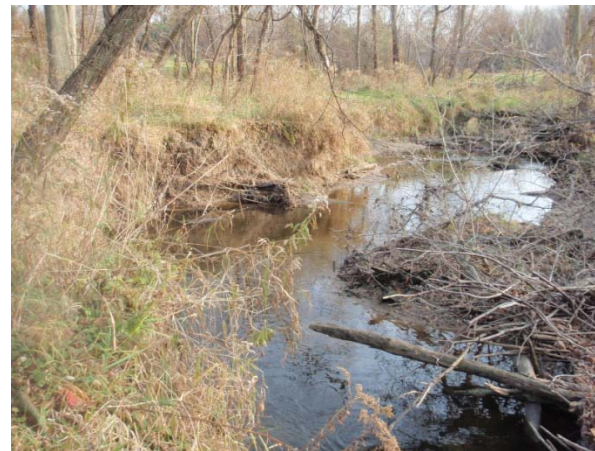
Incised Channel with debris downstream of I-196 BL

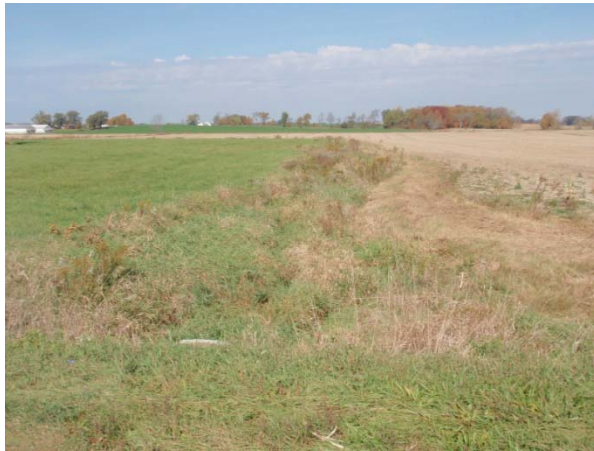
The upper portions of the North Branch, South Branch, and Noordeloos Creek subbasins consist of predominately agricultural lands with extensive drainage networks (dredged open channels). While the channels themselves are generally stable with well vegetated banks, the surrounding landscape is not. Agricultural practices combined with highly erodible soils and poor riparian buffers results in a high potential for generating and delivering a disproportionate amount of sediment and nutrients to nearby waterways. Not surprisingly, some of the highest monitored levels of phosphorus in the watershed are located in the upper reaches of the South Branch and Noordeloos Creek subbasins, where agricultural land use is dominate, soils are highly erodible, and riparian buffers are poor. In general, monitored phosphorous levels tend to decrease in a downstream direction. Therefore, it appears as though a majority of the phosphorous (nutrient) loading in the watershed is being generated from upland sources as opposed to in-stream processes.

Poor Buffer – South Branch Tributary near 138th St.

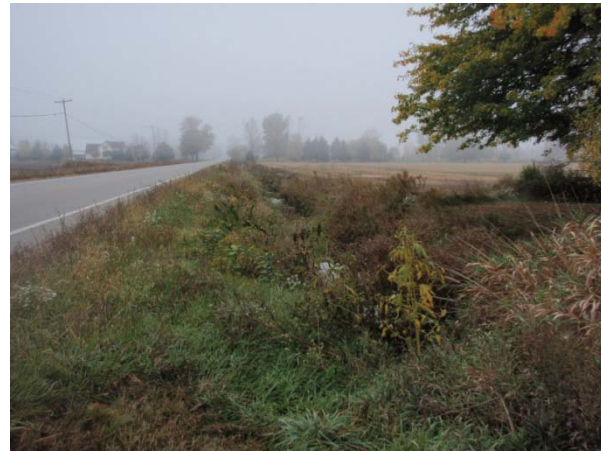
Poor Buffer – Noordeloos Tributary near 96th Street and Barry Street

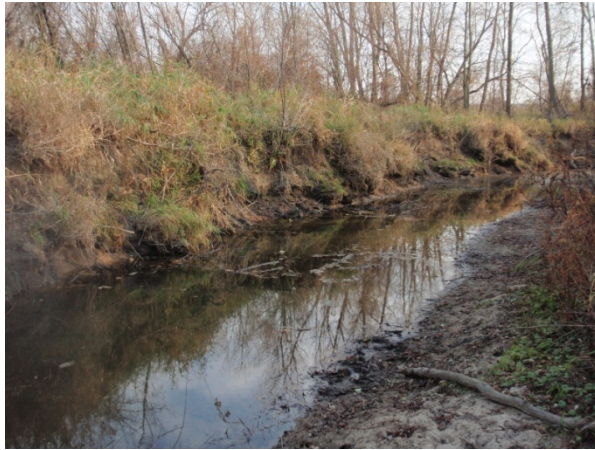
Not surprisingly, the reference reaches selected for geomorphic assessment are located along riffle (grade control) areas with gravel/cobble substrates that are capable of withstanding the increased channel forming (bankfull) flow of the altered hydrology (as indicated by sediment competence analysis conducted as part of the geomorphic assessment) and therefore able to maintain relatively stable.

South Branch - Incised Channel with Sand Substrate

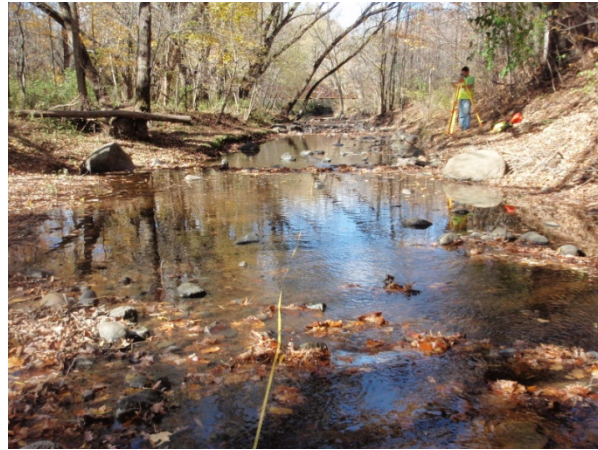
South Branch – Ref. Reach with Gravel/Cobble Substrate
