Joel Evenhouse
Allison Rogowski
Eddie Helderop

Correlating present erosion risk with streambank vegetation and soil composition in the
Macatawa Watershed

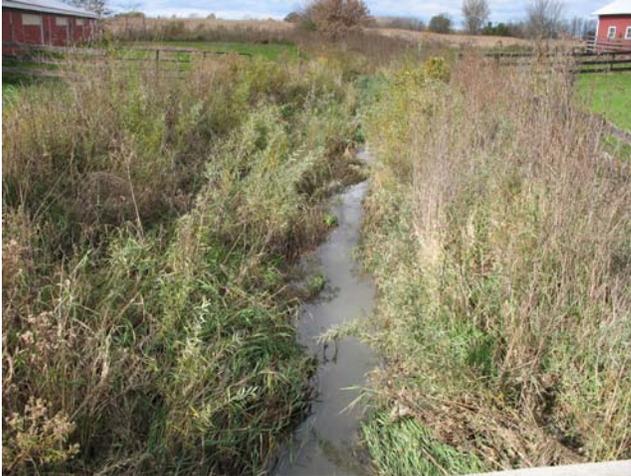
Figure 1- A site from the Macatawa Watershed that scores low on the BEHI scale.

The Bank Erosion Hazard Index (B.E.H.I.) is an assessment of current erosion risk that consists of four metrics which are observational. The first observational metric is the ratio of root depth to bank height, giving a value between 0 and 100 percent based on how far down the bank the roots

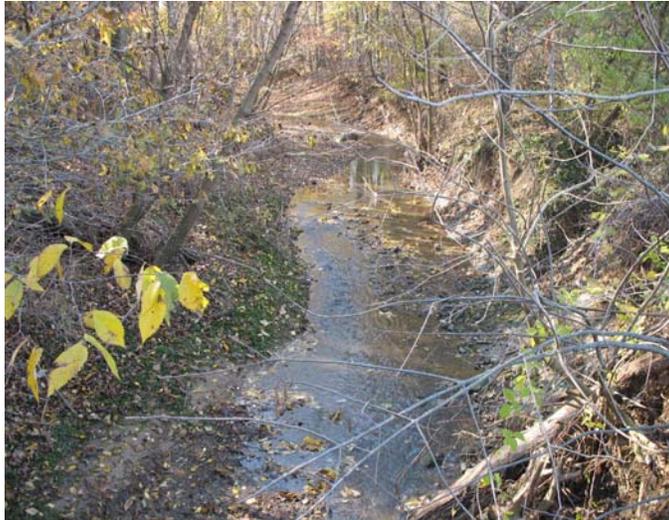
Figure 2- A site from the Macatawa Watershed that scores high on the BEHI scale
