Carcinogens within Lake Macatawa

**Dan Anderson
Kyle Arndt
Calab Nyboer**

12/17/10

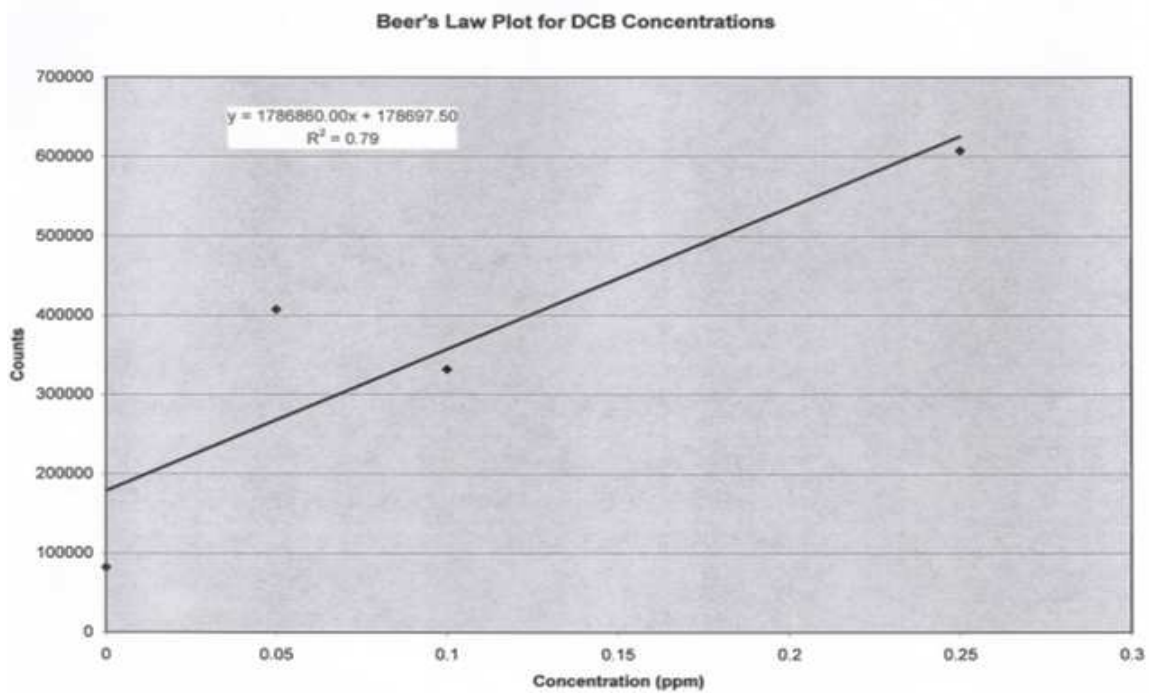
Fig 2:

After the samples had been run, a standardized curve for DCB was calculated using a standard of DCB purchased from Sigma Aldrich. The standard curve can be found at the end of this report listed as Figure 2.

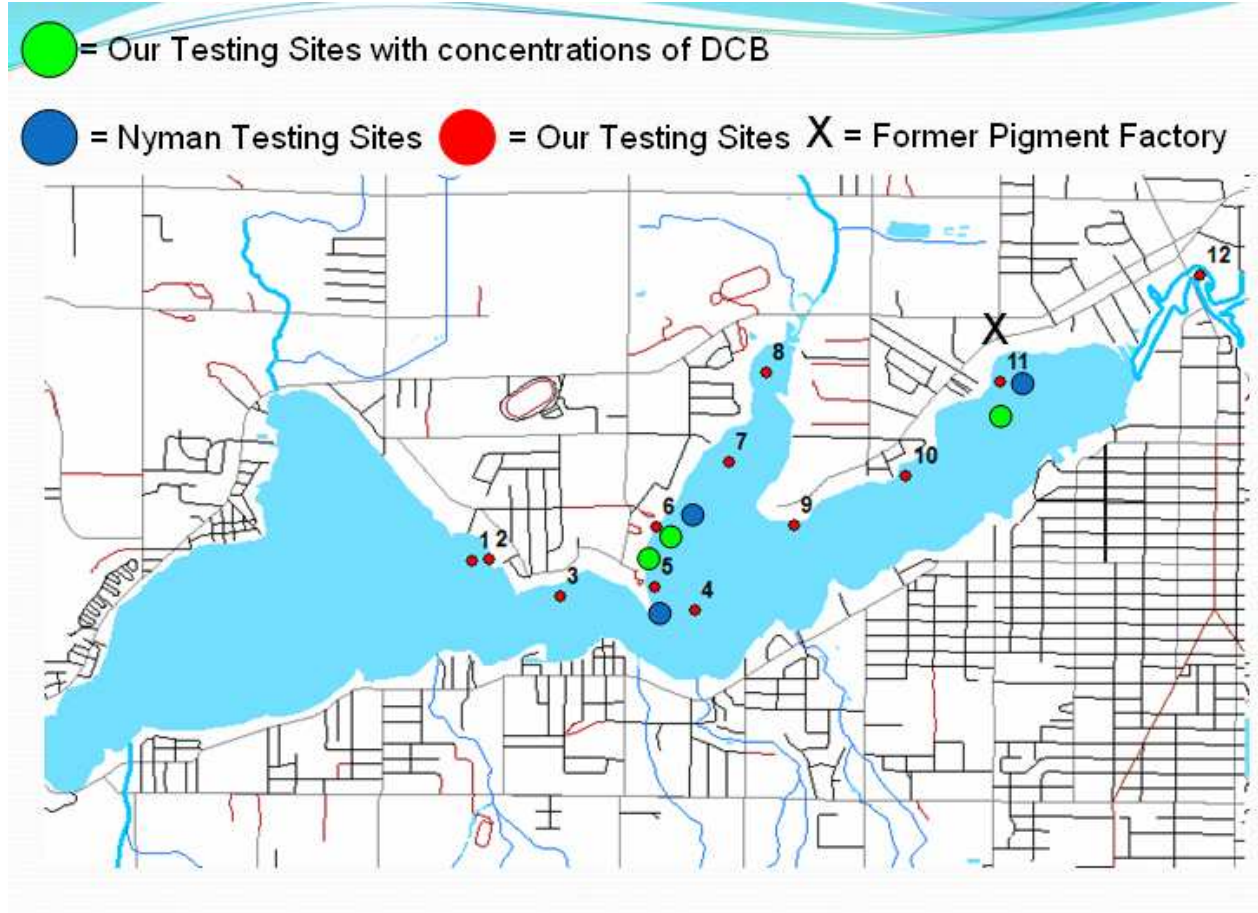
Fig 6:

The results of our study were conclusive with Nyman's results. Figure 3 shows Nyman's table of results she collected during her study. Figure 4 shows one of the sites sampled by us that corresponds to Nyman's data and Figure 5 shows the suspected point source of the contamination. Overall, our data matches up with Nyman's data, indicating that the levels of DCB are in fact going down. Fig 6 shows this correlation between our sites and Nyman's sites.
