Heavy Metals in Drinking Water and Soil on and around Hope College's Campus

Alexandra Donaldson, Ian Gorgenson, and Jarad Jaent

A survey of the
drinking water on
Hope College's
campus

Leachable heavy metals in soils on and near Hope College's campus due to corrosion at the Western Seminary Library

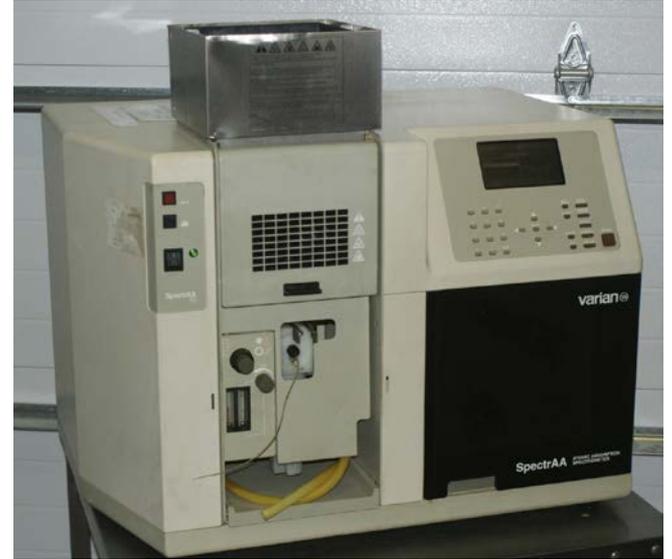
In order to determine the presence of lead and copper in the drinking water samples, they had to be analyzed through Atomic Absorption Spectroscopy.

The Atomic Absorption (AA) would first be able to tell us if lead and copper were present with a preliminary test.

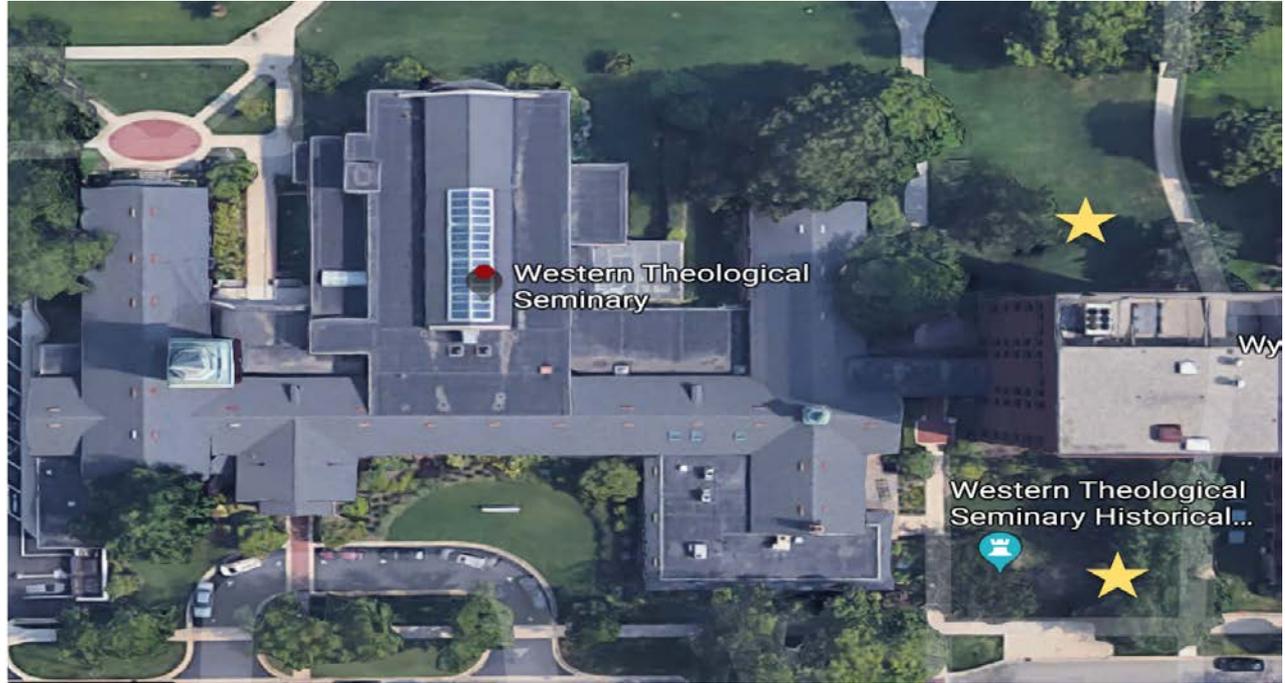
Sampling Location

Two native soil samples were collected from the construction site. One from the front and one from the back, marked with the yellow stars.

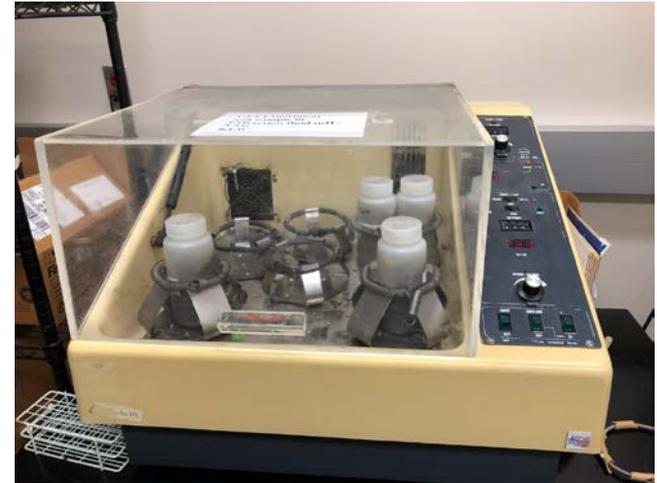
An image of the shaking machine used to agitate our samples and promote leaching

After determining the correct extraction fluid, 100 g of the soil sample were placed in the fluid, and shaken overnight to promote leaching of heavy metals from the soil into the fluid.
