Geomorphic Assessment using the Watershed Assessment of River Stability and Sediment Supply (WARSSS)

**Macatawa Watershed
Ottawa and Allegan Counties, Michigan**

Prepared for:
Macatawa Area Coordinating Council
Holland, Michigan

**April 27, 2011
Project No. G100240**

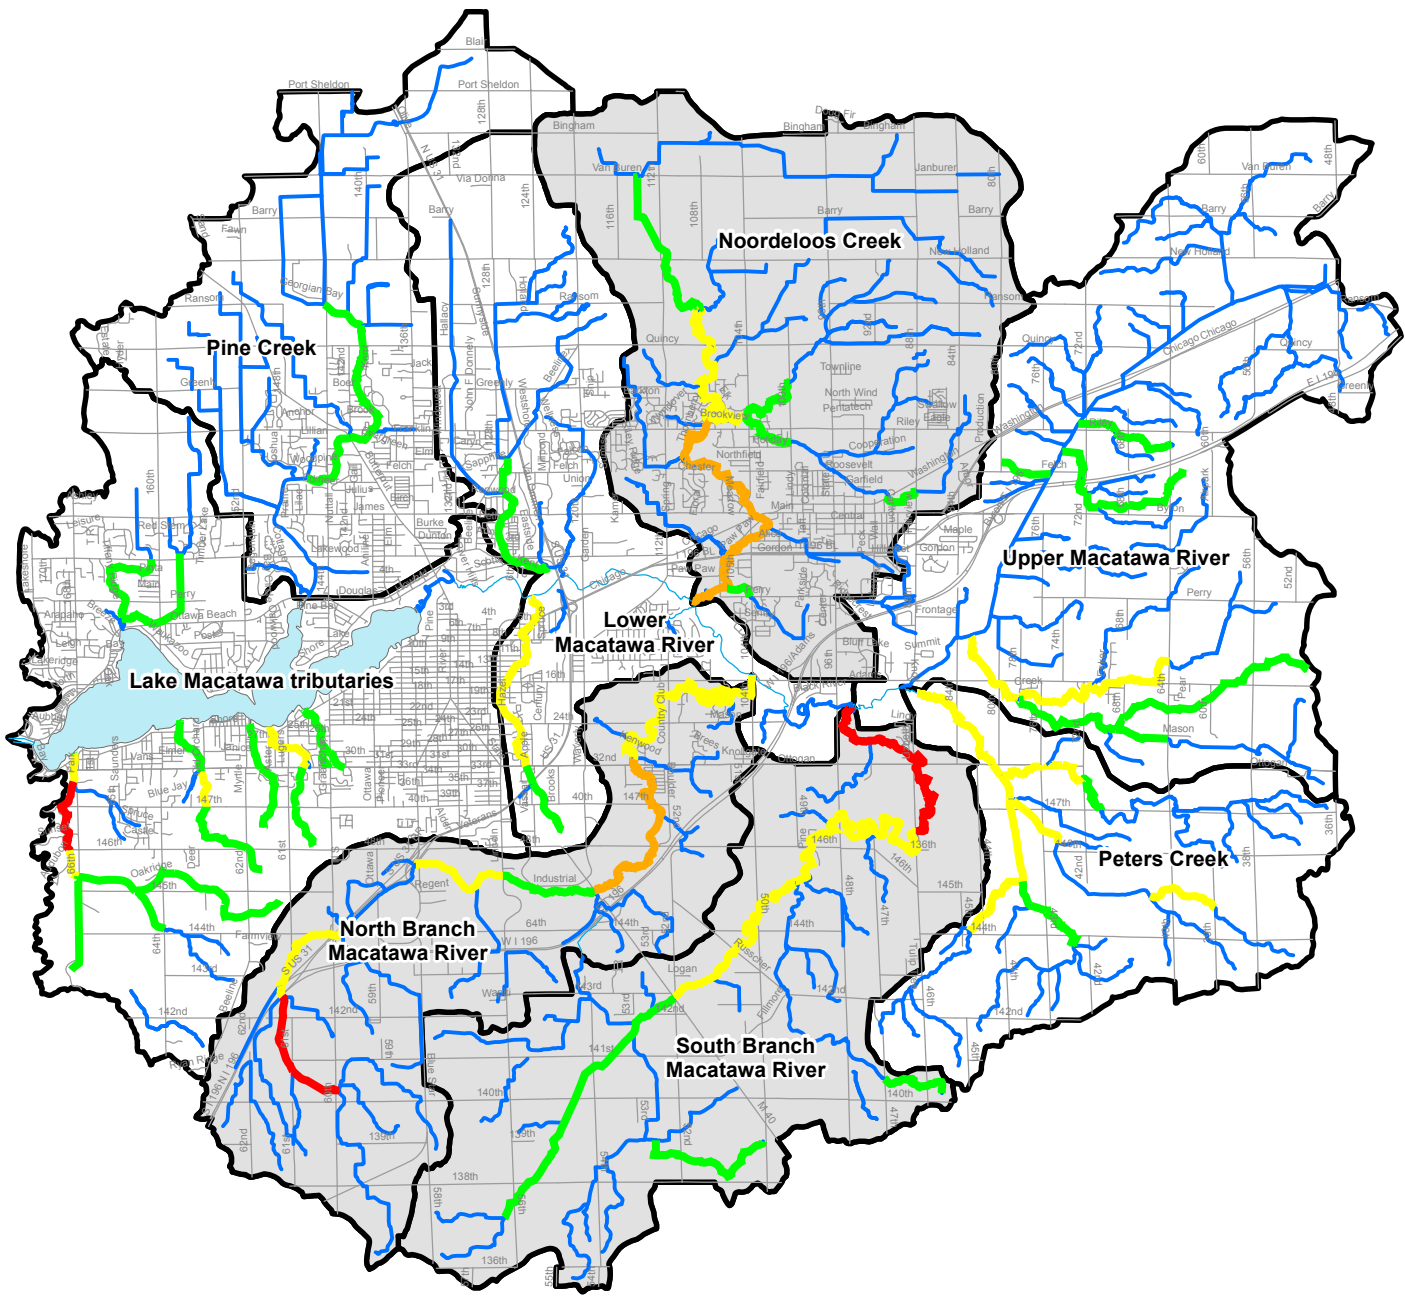
FIGURE 6 - INSTREAM SEDIMENT LOADING

The estimated annual instream sediment load from the entire watershed is approximately 5,571 tons per year. A breakdown of estimated annual instream sediment load by major subbasin is shown in the map provided in Appendix 5. Areas of channel instability categorized by degree of impairment (sediment load in cubic feet per year per linear foot of channel) are shown in Figure 6.

The severity of bank erosion and channel instability is most severe between M-40 and 32nd Street (Ottogan Road) as shown in Figure 6. The majority of the North Branch of the Macatawa River is deeply incised along this stretch, resulting in higher flows and associated shear stresses being confined to the channel. Low bank heights of 5 to 7 feet are common in areas where the mean bankfull depth should be approximately 2.5 feet. The related Bank-Height ratios (lowest bank height to maximum bankfull depth) are greater than 1.5, indicative of a stream that is lowering its local base level (degrading) and capable of contributing a disproportionate amount of sediment from stream bank (and bed) erosion.

The severity of bank erosion and channel instability tends to increase in a downstream direction along Noordeloos Creek as shown in Figure 6. The majority of the main branch of Noordeloos Creek downstream of Riley Street is deeply incised, resulting in higher flows and associated shear stresses being confined to the channel. Low bank heights of 5 to 7 feet are common in areas where the mean bankfull depth should be less than 3 feet. The related Bank-Height ratios (lowest bank height to maximum bankfull depth) are greater than 1.5, indicative of a stream that is lowering its local base level (degrading) and capable of contributing a disproportionate amount of sediment from stream bank (and bed) erosion.

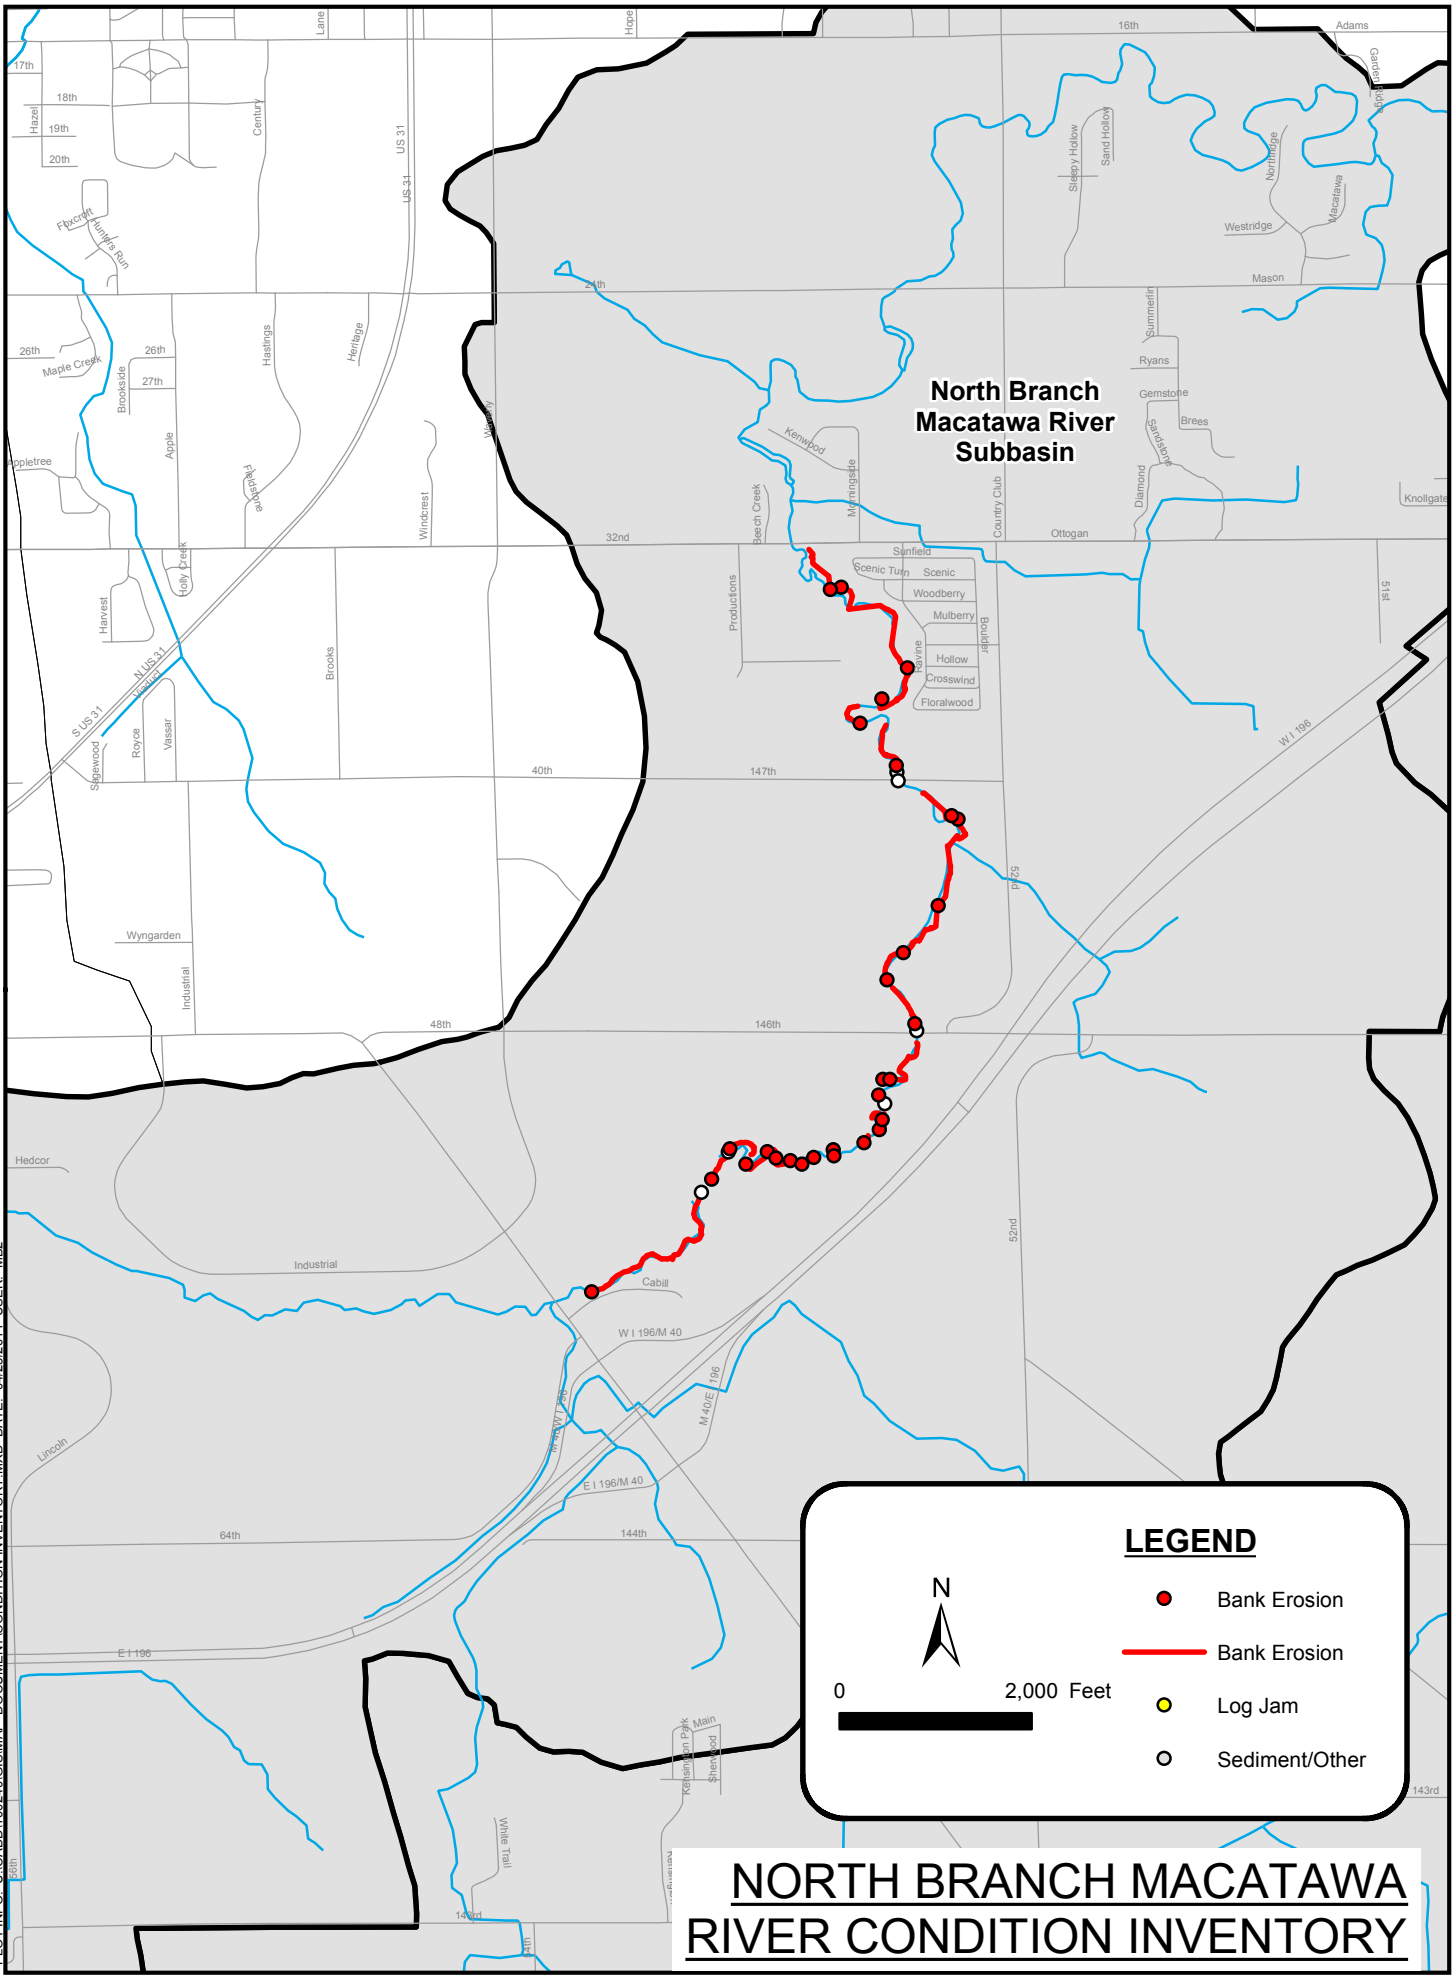
Total Length of Erosion 12205 LF
Total Length of Water Course 14242 LF
 86% of Channel is Eroding
 8284 CF
 307 CY
 0.6 CF of erosion per LF

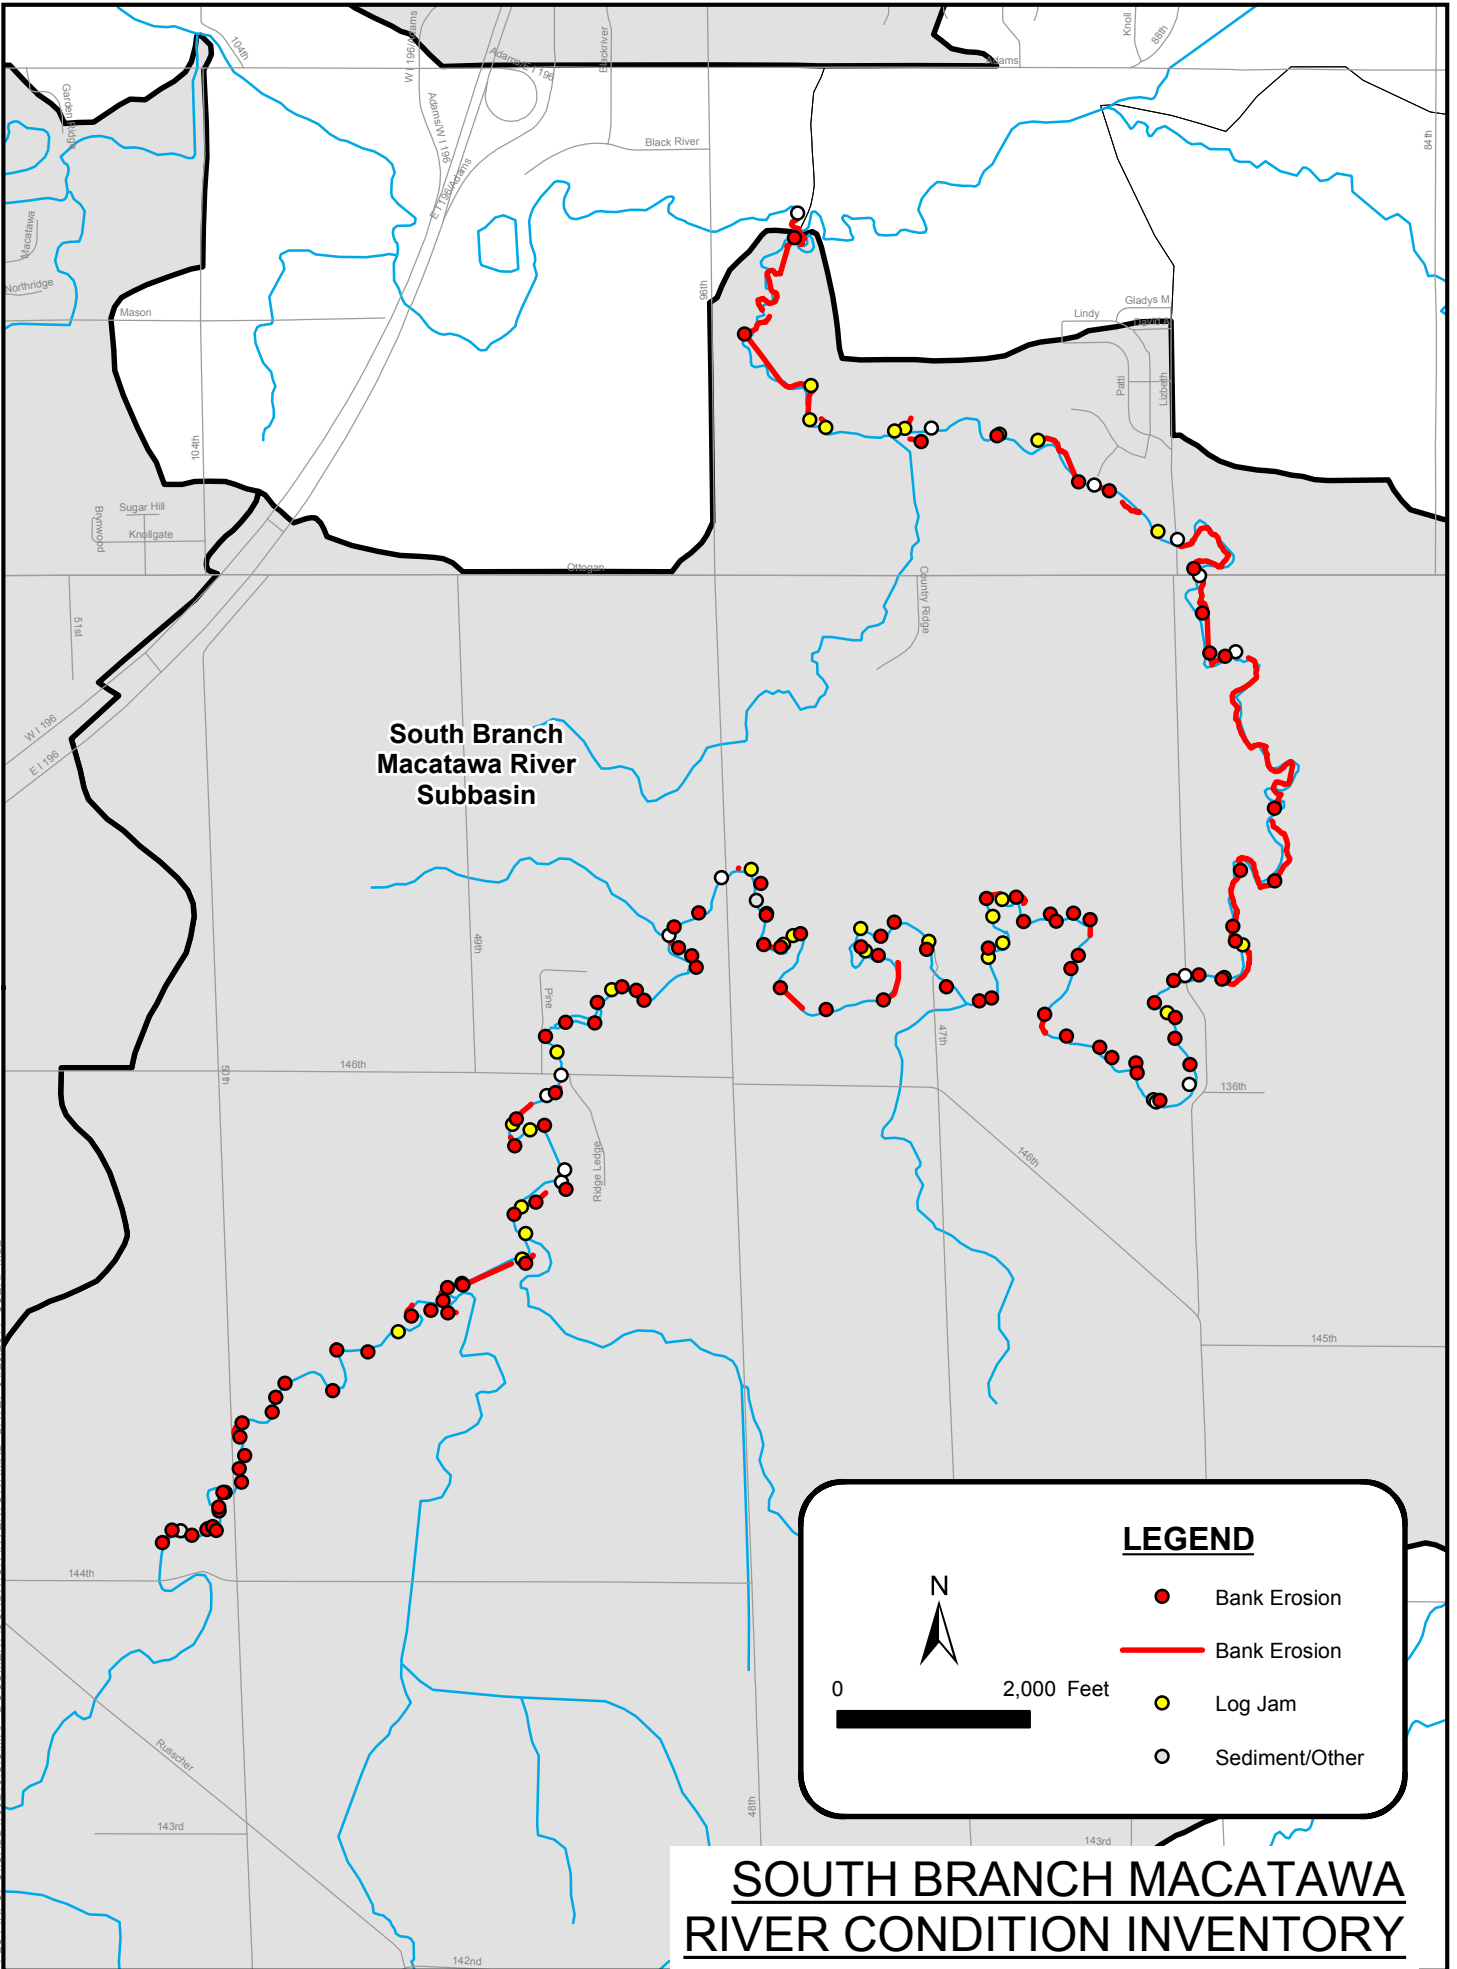
Total Length of Erosion 27225 LF
Total Length of Water Course 45260 LF
 60% of Channel is Eroding
 23614 CF
 875 CY
 0.5 CF of erosion per LF
